# Prior and future earthquake effects in Valdivia, Chile

Efectos previos y futuros del terremoto de Valdivia, Chile

Robb Eric S. Moss<sup>1,2</sup> and Ricardo Moffat<sup>2,3</sup>

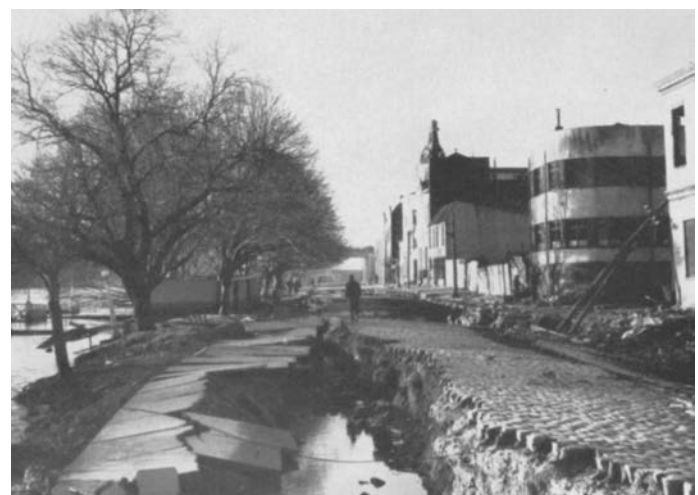
Ground failure due to strong ground shaking was observed throughout the city of Valdivia. Figure 1 shows the ground cracking and slumping observed along the embarcadero, typical of damage throughout the city. The largest deformations and/or highest concentration of building damage is strongly correlated with regions where fill was placed prior to construction. Vertical deformations were typically on the order of 0.15 to 0.45 m, with some locations experiencing up to 0.80 m. No evidence of liquefaction (*i.e.*, sand ejecta) was observed with any of the deformations in Valdivia (Duke and Leeds, 1963; Retamal and Kausel, 1969). However, recent re-evaluation

Figure 1: Ground failure along the Valdivia embarcadero from the 1960 Earthquake (Duke and Leeds, 1963)

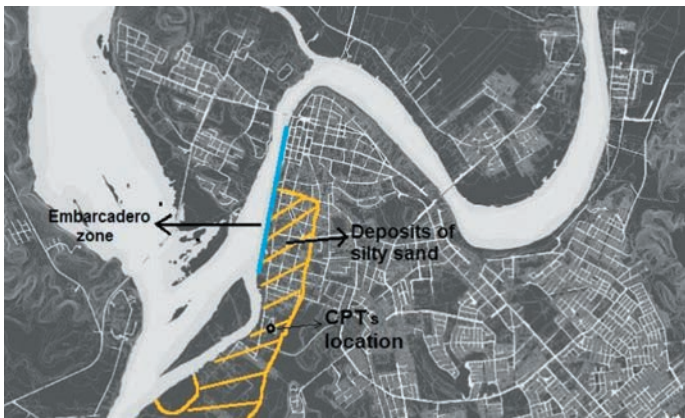
Recent subsurface investigations (per LMMG Geotecnia Limitada) have used sCPTu to measure the in situ conditions of soils around Valdivia. In this study we look at two soundings (Figure 2) that were recently performed near the embarcadero (coincident with Figure 1) that experienced ground failure in the 1960 seismic event. In this zone it has been found deposits of silty sands as it is shown in Figure 2 according to Arenas *et al.* (2005).

Figure 2: Location of CPTu soundings performed on silty soil deposit

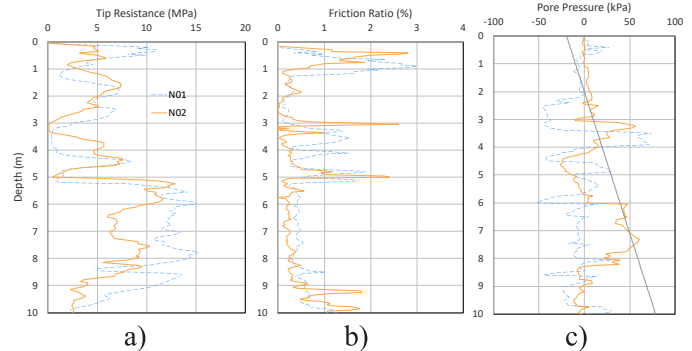
The profile in Figure 3 indicates interlayered variable soil. Trends show sandy regions in the 1.0 to 3.0 m depth and 5.5 to 8.5 m depth as indicated by relatively high tip resistance and corresponding low friction ratio. The region from 3.0 to 5.0 m depth contains layers of plastic silts/clays as indicated by the relatively low tip resistance and variable to high friction ratio. Based on the elevation of the site and the elevation of the nearby water way the depth to the

Figure 3: Two sCPTu soundings performed along the embarcadero in downtown Valdivia, showing measurements of: a) cone tip resistance, b) friction ratio, and c) pore pressure. The elevation of the site is +8 m above sea level and the water table has been estimated at a depth of 2 m as shown in the pore pressure plot.

To evaluate the feasibility of seismic induced ground deformation due to the plastic fines the CPTu data in Figure 3 was used to calculate the cyclic resistance per equation (2). To do that the undrained shear strength of the soil was first calculated per equation (3) where a median cone factor  $N_k$  of 12 was used (Robertson and Cabal, 2015). The unit weight of the soils was assumed to be roughly  $18 \text{ kN/m}^3$ .

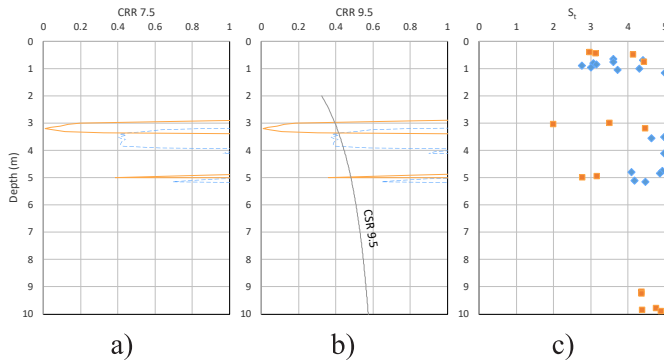
Figure 4 shows the cyclic resistance results. Figure 4b shows the estimate of the cyclic resistance of the clayey soil versus the cyclic stress from 0.5g peak ground acceleration. The estimated value of  $PGA = 0.5g$  was obtained from a probability of 10% of being exceeded in 50 years (corresponding to 475 years return period as shown by Leyton *et al.*, 2009). What can be seen is that the loading is higher than the resistance over a half a meter thick layer in

the 3.0 to 4.0 m depth range. The corresponding sensitivity of the soil is 2 or higher in this region as well. Based on these rough calculations a large magnitude event such as the 1960 event that produced peak ground accelerations upwards of 0.5g could cause the clayey soil to fail, and the sensitivity indicates that once failed the soil would exhibit strain softening that could result in co-seismic and/or post-seismic deformations until the final static shear stresses are balanced by the residual shear strength.

Figure 4: Cyclic failure assessment. a) Cyclic Resistance Ratio *CRR* for  $M = 7.5$ , b) *CRR* for  $M \sim 9.5$  and Cyclic Stress Ratio *CSR* corresponding to a  $M \sim 9.5$  and  $PGA \sim 0.5g$ , and c) soil sensitivity

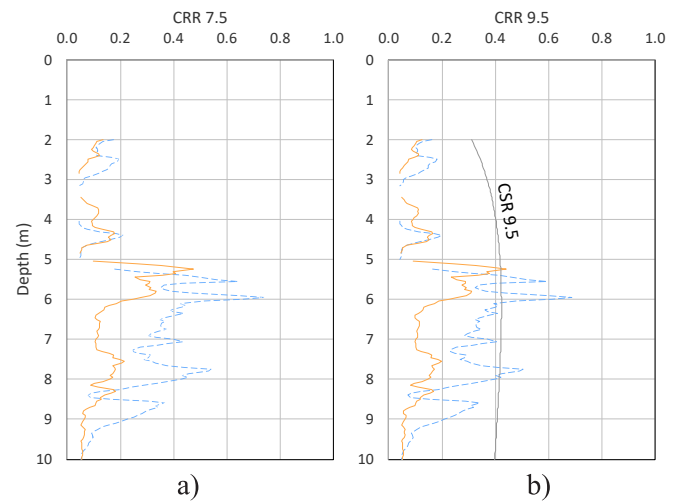
The results are shown in Figure 5. From the assumed water table at 2 m down to 3 m, and then from 3.5 to 5 m we see layers where liquefaction is likely for non-plastic to low-plastic soils and this loading situation. Deeper liquefaction is also likely, but it is not as commonly observed at the ground surface based on prior liquefaction case histories (Moss *et al.*, 2006).

Figure 5: Liquefaction triggering assessment. a) Cyclic Resistance Ratio *CRR* for  $M = 7.5$  and b) *CRR* for  $M \sim 9.5$ , the Cyclic Stress Ratio *CSR* corresponding to a  $M \sim 9.5$  and  $PGA \sim 0.5g$

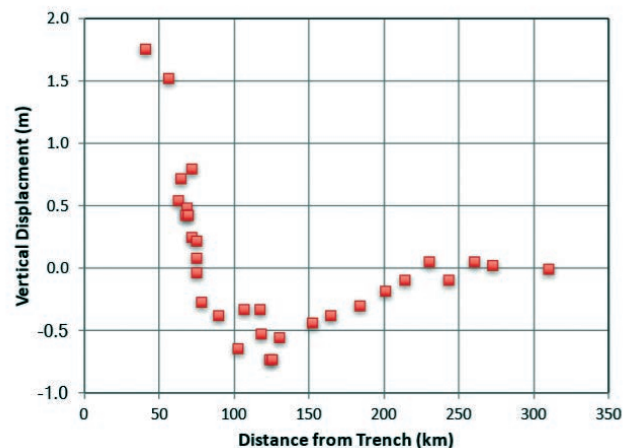
Data from the 2010 Maule event (after Vigny *et al.*, 2011) is shown in Figure 6. The data is plotted as the perpendicular distance from the trench in kilometers versus the co-seismic displacement in meters. The data is an aggregate of two cross-sections, one at the latitude of Constitucion (35.5°S to 36.0°S) and the other at the latitude of Concepcion (37.0°S to 37.5°S).

Figure 6: Plot of vertical co-seismic tectonic deformations (m) as a function of fault-perpendicular distance from the trench (km) from the 2010 Maule earthquake (after Vigny *et al.*, 2011)

The pattern observed in Figure 6 has a very curious shape,

not following a simple exponential decay or similar physical process. The shape lends to being modeled by a damped harmonic function, which is commonly used in structural dynamics to explain the response of structural components/systems that have some stiffness and some damping (Chopra, 1995, p. 339). Damping is a “catch all” term used to describe some mechanism by which energy is dissipated in a structural component/system, and includes both frequency dependent and frequency independent mechanisms. The mathematical function that describes an under-damped harmonic oscillator is:

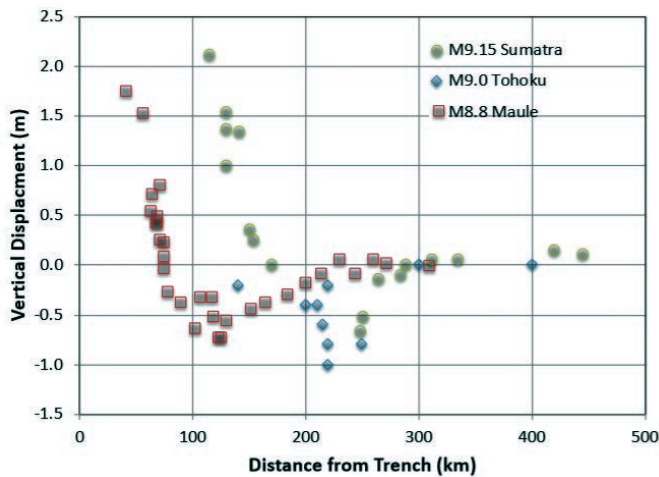
Figure 7: Comparison plot of the co-seismic tectonic deformations from the 2004 Sumatra, 2011 Tohoku, and 2010 Maule earthquakes

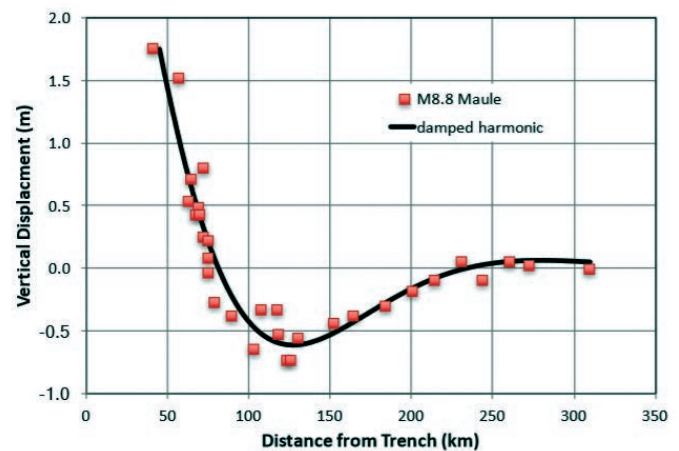
The utility of this function (6) becomes apparent when it is fit to the co-seismic data. As can be seen in Figure 8 the function (6) can mimic the observed peak uplift, peak

subsidence, and approach to zero with reasonable accuracy (nonlinear regression fit with  $R^2 \cong 0.9$ ). This function also captures the observed uplift that occurs at a distance greater than that of peak subsidence before the approach to zero.

Figure 8: Co-seismic deformation data from 2010 Maule event fit with a damped harmonic oscillator function using nonlinear regression ( $R^2 = 0.9$ )
