# Design, construction, operation and the effect of fines content and permeability on the seismic performance of tailings sand dams in Chile

Luis Valenzuela

Geotechnical consultant, Montecassino 929, las Condes, Santiago, Chile (formerly Arcadis Chile), valenzuelapluis@gmail.cl

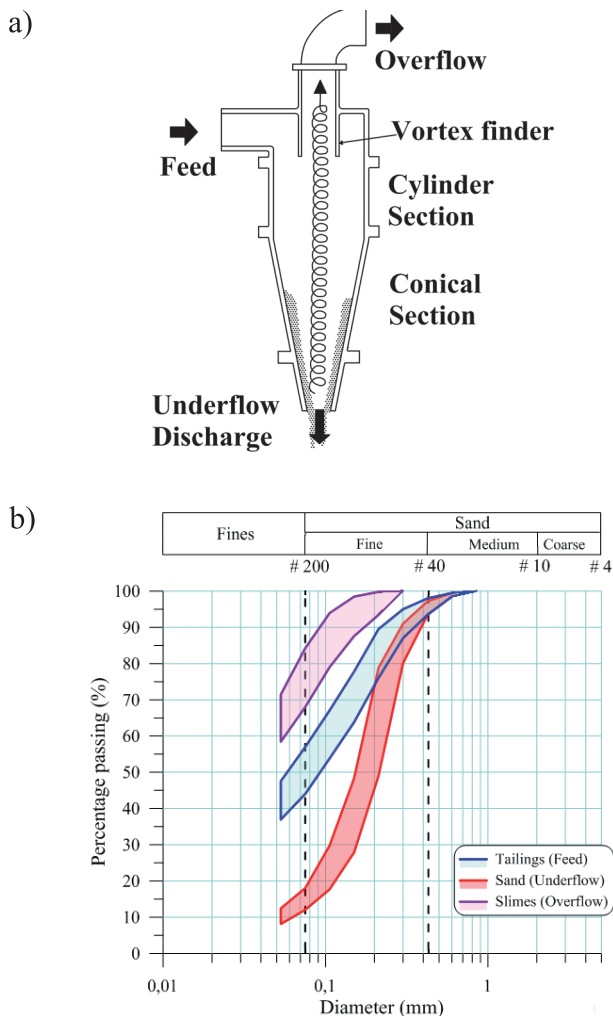
Figure 1: a) Scheme of a cyclone and b) typical range of particle size distribution for tailings (feed), sands (underflow), and slimes (overflow).

fill dams that use waste rock from the mine when available at an economical transport distance. In contrast with hydraulic fill dams for water reservoirs, the material used to build tailings sand dams is not natural borrowed soil, but the mine tailings themselves. A centrifugal mechanical device called a cyclone separates the tailings into a coarse portion, generically referred to as sand, and a fine portion, generally referred to as slime (Figure 1a). Figure 1b shows a typical particle size distribution range for copper tailings (feed) and for the resulting sands (underflow) and slimes

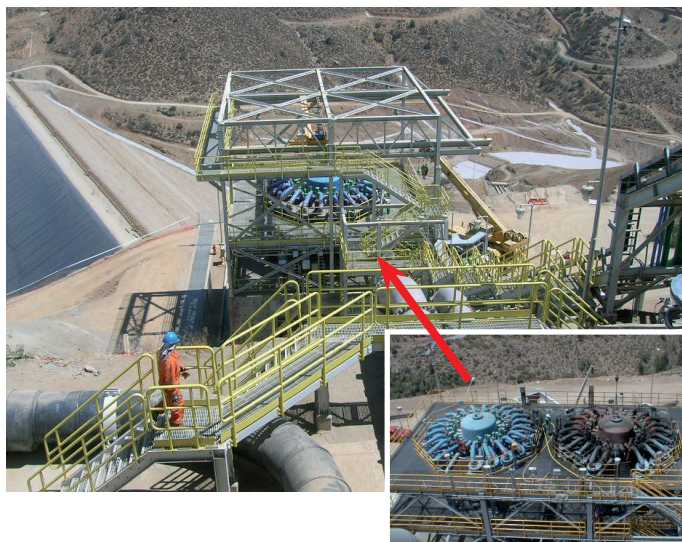
Figure 2: Cluster of cyclones from Quillayes tailings deposit

Cyclones may operate individually or in a cluster consisting of several cyclones (Figure 2). Both types of cyclone may be fixed or mobile, the latter being able to move on the crest of the dam under construction.

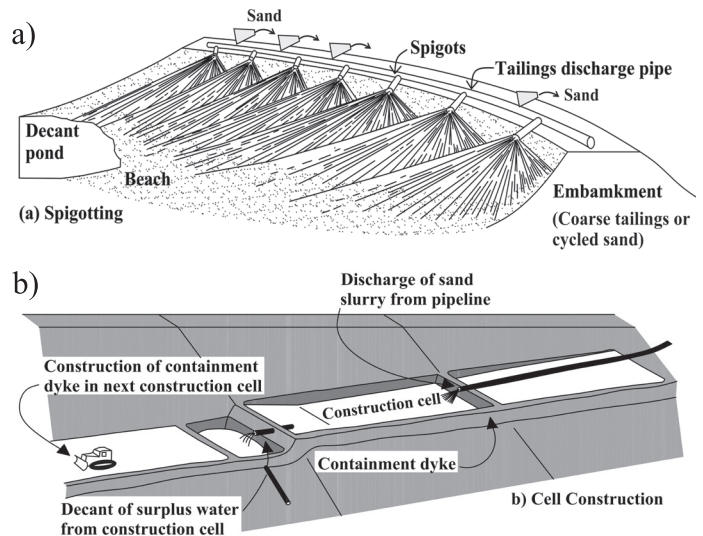
Figure 4: a) Sand deposited on the slope from the dam crest and b) sand deposited in cells

In the construction of these dams, sand can be deposited hydraulically directly on the growing dam slope or, alternatively, deposited in cells as shown on Figure 4. Both deposition methods allow for sand to be compacted in layers thin enough to attain design densities, especially in the downstream and centerline construction methods.

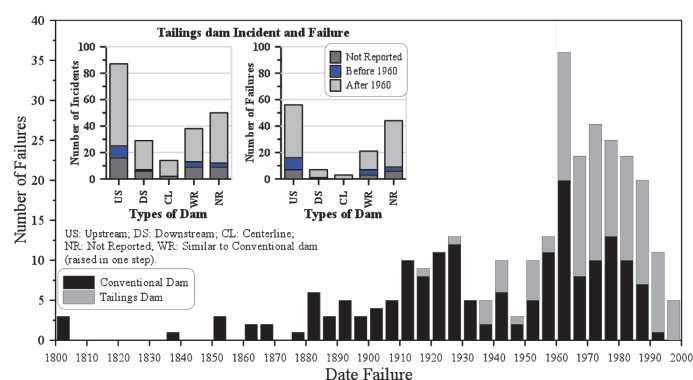
Figure 5: Statistics on dam failures according to ICOLD (1995, 2001)

Figure 5 shows that, during the period between years 1800 and 2000, the recorded number of tailings dam failures represents 40% of the total number of failures. However, this percentage increased considerably between 1960 and 2000, reaching 70%. This increase occurred in the period when the mining industry, especially metal mining, experienced a major production increase. The probability of failure of tailings dams has been estimated to be of the order of 1:700 to 1:1750 (Davies *et al.*, 2000), a figure that is much higher than for conventional dams used for water impoundment, estimated some years ago by Peck (1980) at 1:10000. Figures obtained in recent years have

Published statistics have shown that tailings dams constructed using the upstream method have frequently suffered some type of incident<sup>1</sup>, as shown in Figure 5. Historically, upstream dams have been the most common and numerous tailings dams, as they are more economical in both investment and operating cost. The number of sand dams constructed by other methods – downstream and centerline – and even using other materials, such as rock-fill or compacted earth, has grown significantly during the last three to four decades, but in relative terms upstream dams continue to fail most often, especially in highly seismic countries such as Chile and Japan. In China, Wei *et al.* (2013) mention that the majority of tailings dam failures have been upstream dams, which caused 573 fatalities between 1962 and 2008. However, the authors acknowledge the numerous upstream dams in China that have performed satisfactorily, as discussed below.

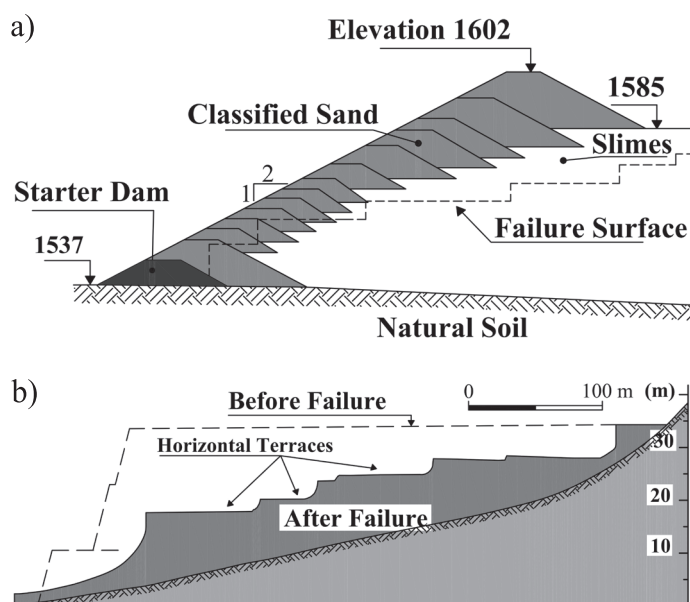
Figure 6: a) Cross-section of the Barahona N° 1 dam, showing the failure mechanism (Troncoso *et al.*, 1993) and b) El Cobre N°1 dam profile before and after the failure (Dobry and Alvarez, 1967)

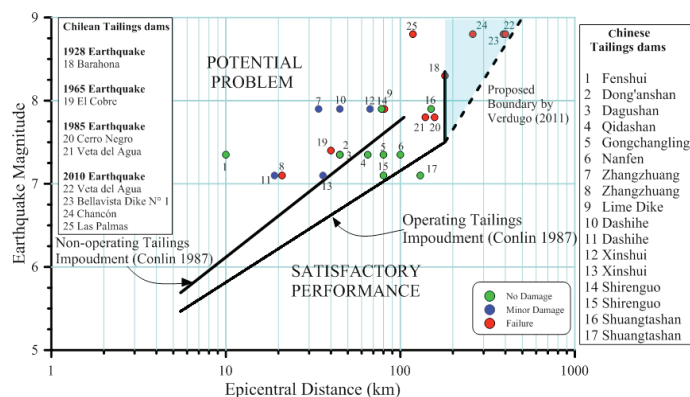
Figure 9: Susceptibility of upstream tailings dams to suffer damage due to earthquakes (Conlin, 1987; Lo *et al.*, 1988; Verdugo, 2011)

Figure 9 includes the graph prepared by Conlin (1987) and complemented by Lo *et al.* (1988) and Verdugo (2011), showing several of the upstream dams that have failed,

and others that have not, according to the magnitude of the earthquake and the distance from the epicenter in the case of each dam, indicating a possible boundary between the two types of behaviour. However, distance from the epicenter in the case of the 2010 earthquake could be misleading, since this was a subduction earthquake with a very long N-S plate rupture some 500 km in length along the coast. Consequently, if the distance from the plate rupture zone is taken into consideration for each of the dams that failed in Chile in the 2010 earthquake instead of their distance from the epicenter, the limit proposed by Conlin (1987) probably would be valid even for high magnitude events.

order of 1:4 to 1:5 (V: H), and because deposited sands had a lower concentration of solids – in the order of 20% in weight – to facilitate formation of those slopes. In Figure 9 a number of Chinese upstream tailings sand dams have been included as reference. It is clear that most of Chinese tailings dams which did not have any stability problems, are well to the left of the Conlin dividing lines. This difference is due to the different construction characteristics of the dams. In the case of Chile the dams that have failed were upstream sand dams with relatively steep downstream slopes, ranging between 1:1.5 and 1:2 (V: H).

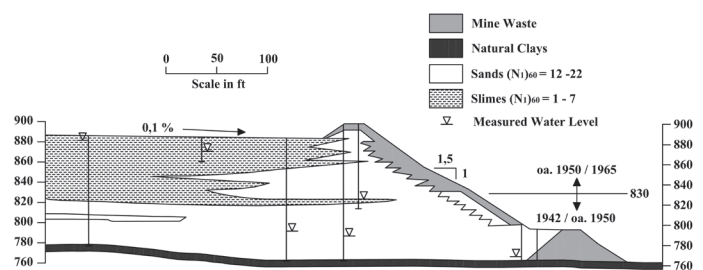
Figure 10: Section of the Main St. Joe tailings dam (Vick *et al.*, 1993, Finn, 1996)

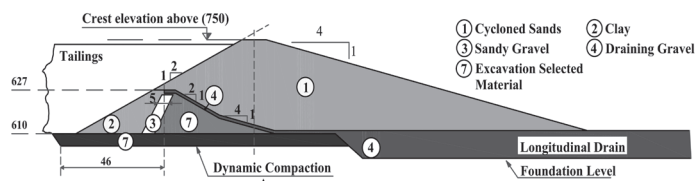
Figure 11: Cross-section of the main dam of the Las Tórtolas tailings deposit (Valenzuela, 1996)

Las Tórtolas tailings deposit is located at an elevation of 700 masl, 45 km north of Santiago, in Chile's central valley (Valenzuela, 1996). Studies of this dam, initiated in 1984, analyzed in detail the experience gained up to that date in El Cobre N°4 and Pérez Caldera N°2. The adopted design included a maximum final height of 150 m, some 30 m higher than Pérez Caldera N°2. In this dam, shown in cross section in Figure 11, conservative original design criteria included a double cyclone station to guarantee 10% maximum fines content FC in the sand. The design considered the implementation of a network of instruments, including piezometers and accelerometers. This is the first dam that was subjected to a dynamic stability and deformational analysis using the finite differences method (DSAG at the time, which later gave birth to FLAC). Satisfactory performance of this dam, which began operating in 1992, made it possible to increase FC to 15% a few years later and to define a new maximum height of 170 m. The current height of this dam is about 90 m. Design of this deposit initially set a maximum capacity of 1000 million tons of tailings, and recent estimates increased that capacity to 2000 million tons. The deposit has two other smaller cycloned sand dams, all constructed using the downstream method. In the main dam, the starter dam consists of compacted earth 17 m high. Approximately 5 m of loose alluvial soil were excavated under the starter dam and under part of the sand dam, after which dynamic compaction was applied to the foundation. The rest of the foundation consists of denser gravelly sands. The downstream slope of the starter dam was constructed with a very shallow gradient in order to facilitate initial deposition of sands. The dam is equipped with generous basal drains that were built in stages. The dam was constructed with cycloned sands and compacted to 95% Proctor Standard. The sand was initially deposited forming a slope of 1:4 (V:H). After a few years of operation, and after verification of very satisfactory dam performance

confirmed by density controls and piezometric level records, the deposition slope was changed to 1:3.5 (V:H). A final slope of 1:3 (V:H) is considered for the closure stage.

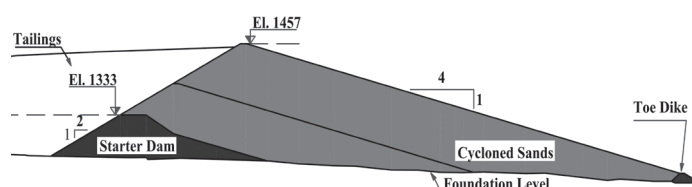
Figure 12: Cross-section of the Quillayes dam (Valenzuela and Campaña, 2014)

tunnel with a 30 m<sup>2</sup> cross-section. The low impoundment/dam ratio and the high daily production of tailings to be deposited, some 100000 TMPD<sup>3</sup>, determined the need for a 70 m-high starter dam constructed of compacted clayish sandy gravel. It was necessary to cyclone 100% of the tailings to produce enough sand for the dam to grow at the rapid rate required during the early years, reaching a record 37 m above the starter dam crest during the first year. Given the narrowness of the valley, the initial years offered the greatest challenges to construction, arranging sands on the slope from sand pipelines at intermediate heights, and placing sands hydraulically at the foot of the dam via sub-horizontal cells. The cross-section of the dam is shown in Figure 12.

The dam foundation consists of 8 m-thick fluvial deposits, colluvium deposits in the left abutment (3 m) and intrusive granodiorite rock in the right abutment. Soil deposits are of medium to high compaction, and considered not susceptible to liquefaction. Construction of this downstream tailings sand dam was begun in November 1998 and completed in July 2008, after deposition of close to 78 million m<sup>3</sup> of sand to the dam's maximum height of 198 m. Up to one million m<sup>3</sup> of sand were deposited and compacted per month while the deposit was in operation. The tailings produced in the concentrate plant consisted of a sandy slime with 80% in weight of soil with a size of approximately 212 microns and 50% fines under 200 mesh. Sands were specified to contain a maximum of 18% fines, and up to a maximum of 20% of samples were accepted with a content of maximum 20% fines. Sands were obtained from a fixed automated cyclone station installed at a convenient height on the right abutment of the dam, consisting of two sets or clusters of 20 cyclones each, which have been shown in Figure 2. Another interesting characteristic of this dam is that construction and operation were undertaken in their totality by a consortium that included the firm responsible for the

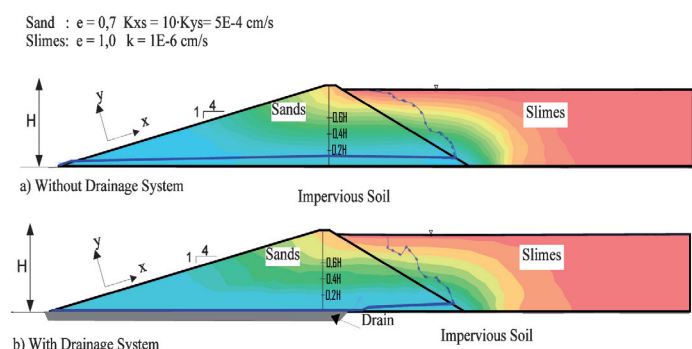
Figure 13: Flow network for a typical tailings dam cross-section showing phreatic level in blue line

Permeability of sands and the hydraulic capacity of the basal drains are key properties for dam stability. Downstream and centerline dams are designed to prevent saturation of the sandy body of the, or at least to limit saturation to a very restricted zone at the base of the dam, where there must be a generous network of basal drains to prevent the phreatic level from exceeding design conditions. Adequate design of this type of dam requires that sand permeability exceed permeability of the deposited tailings and/or slimes in contact with the dam by two to three orders of magnitude, guaranteeing that the flow of water from the deposited tailings and from the water used for transport and deposition of sands will be as close as possible to the gravitational flow within an unsaturated medium, thus reaching the basal drains quickly. Vick (1983) shows that the greater the contrast in permeability between sands and tailings or slimes, the lower the phreatic level that will be maintained. Following are the results of seepage analysis specifically done in a tailings sand dam with a cross section according to common practice in Chile on this type of dam. Figure 13a shows the results for a case in which permeability of sands is 500 times the permeability of slimes (permeability of  $10^{-6}$  cm/s for slimes and  $5 \cdot 10^{-4}$  cm/s for sands), in addition to tenfold anisotropy of sands in the direction of the slope, confirming that the phreatic level increases to up to 18% of the maximum height (assuming that the foundation soil is impervious). Figure 13b shows the same example, but including a drainage system that covers 75% of the base of the dam. In this case, the phreatic level is only present in the upstream portion of the dam immediately where the basal drain begins, and up to a

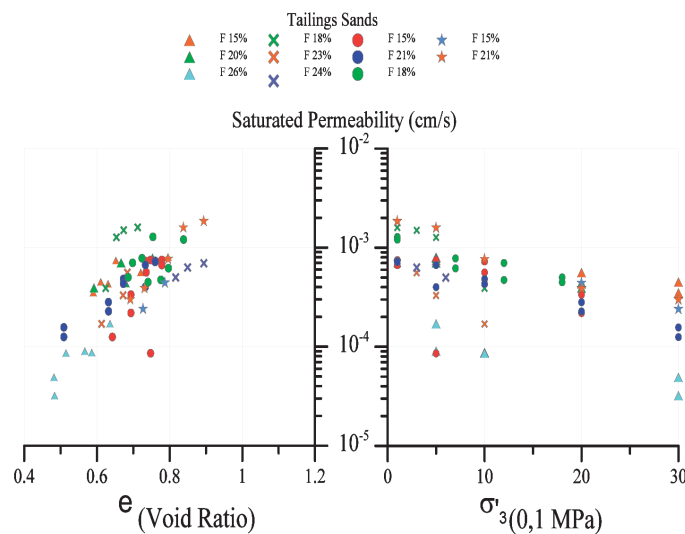
Figure 14: Permeability  $k$  as a function of void ratio  $e$  and confinement pressure  $\sigma'_3$ , for several tailings sands with various contents of fines.

Figure 14 also shows in a very clear trend that permeability decline as confinement pressure is increased, making it possible for permeability to be reduced by up to one order of magnitude within the range of 0 to 3 MPa. This is generally addressed during the design stage when stability analyses are conducted, assuming a conservative saturation line in the lower part of the body of the dam, with a higher saturation line in the sectors with greater confinement pressure. Based on data in Figures 14 and 15, the dependence of permeability on the level of confinement

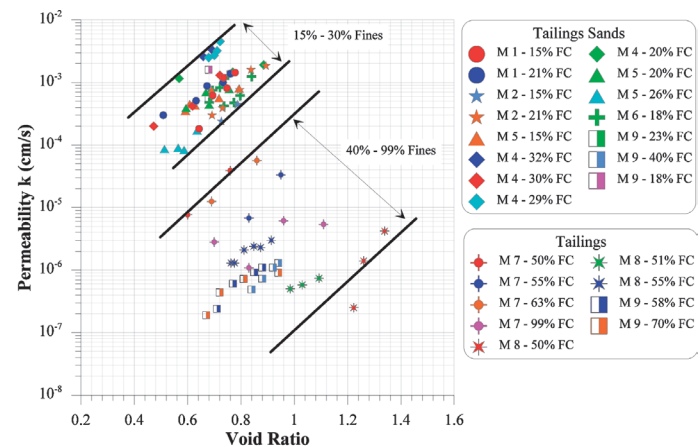
Figure 15: Permeability  $k$  as a function of void ratio  $e$ , for typical tailings sands with various contents of fines (Campaña *et al.*, 2015)

maximum height of the order of 0.05H. The permeability values used in the models are typical of those seen in this type of material, as can be seen in Figure 15.

but also leaves enough of a safety margin to ensure proper drainage if tailings segregation provokes the formation of sectors with higher FC values, or if high confinement pressures generate higher contents of fines due to the break-up of particles. The relationship between permeability and percentage of fines is not quite as clear, or as general, as discussed below, but within the range of 10 to 25 - 30% of FC, variations have been measured in the laboratory of up to one order of magnitude, as shown in Figure 14. Regulations in Chile, for example, for the design and construction of tailings sand dams require a FC in sands no greater than 20% (MM, 2007). The most marked differences in permeability are seen in tailings with FC values above 30 to 40%, probably as a result of a change in the structure of the soil skeleton, since coarse grains would not all be in contact and fines would then not only fill the spaces left by the skeleton of coarse grains but would also partly replace the grain-to-grain-contact (see Figure 15).

pressure, as well as on the void ratio and relative density, is clear for the samples with FC levels between 15 and 30%. However, Figure 15 shows that in samples with a higher FC, in this case 30%, the behaviour deviates from that of sands with a lower FC value, indicating a change in the structure of the sand skeleton. Permeability tests of sands with an FC value ranging between 15 and 23% do not show substantial differences between them, leading to the determination of relatively high maximum FC values in some projects. However, that criterion does not leave enough leeway for eventual increases in the FC value due to segregation, break-up of particles, or variations in the particle size of sands, and eventually, in their mineralogy. It is therefore advisable to design with maximum FC well below 20%. The current practice for tailings dams is to fix the percentage of fines between 15 and 19%, and between 15 and 17% for taller dams, which leaves a margin of safety for permeability variations and for the possible negative impacts of other factors. However, the results discussed herein indicate that specific permeability tests should be conducted during the different phases to confirm the parameters considered in the early studies, *i.e.*, before construction, with samples from available sands or from pilot tests; during construction, with samples of sands produced during the construction and operation of the deposit and, each time there is a clear change in the characteristics of the tailings, such as grain size distribution, mineralogy, and chemistry.

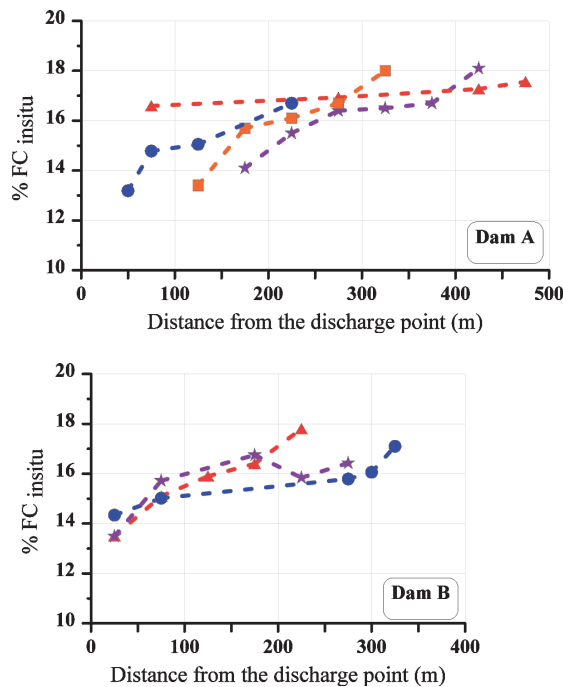
Figure 16: Fines segregation in sands deposited hydraulically in slopes of 1:3.5 to 1:4.0 (V:H) (Figueroa *et al.*, 2015)

more important in very tall dams, must be considered. This factor can become significant in some cases, causing a FC value increase of 2 to 3%, as shown on Figure 16, which could require that the cyclone underflow have a lower FC value than the maximum design value, to compensate for the segregation effect (Figueroa *et al.*, 2015).

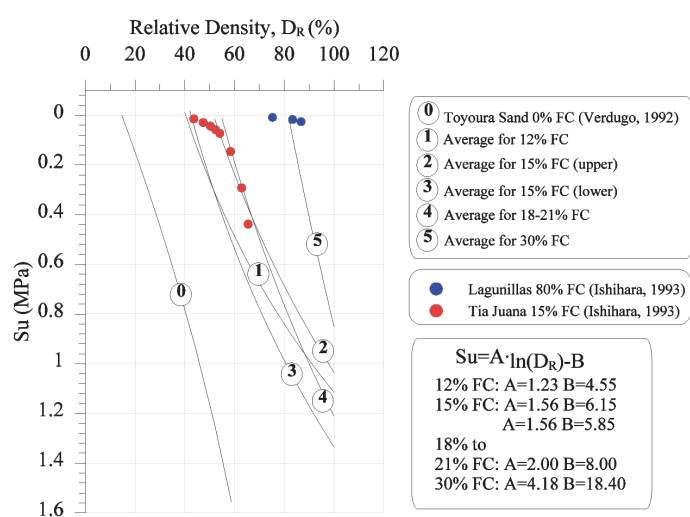
Figure 18:  $s_u$  as a function of content of fines and comparison with the results of Toyoura sand (adapted from Bard *et al.*, 2014)

Figure 18 shows variations of undrained shear resistance  $s_u$  as a function of FC and of relative density  $D_R$  obtained

at the end of the isotropic consolidation phase of the test specimen. The figure shows the average trends of the tested samples, compared with the trend obtained in Toyoura sand with 0% fines (Verdugo, 1992), Tía Juana silty sand with 15% fines (Ishihara, 1993), and Lagunillas sandy silt with 80% fines, all of them for a wide range of relative densities. Sands with 30% of fines, would require a much higher density than the one required by sands with a FC between 12 and 21%, apparently confirming the results of other tests showing that, over a certain FC value, of 25 to 30%, there would be a change in structure of the granular skeleton of the soil.
